Shearwater Teric Firmware v16 Release Notes

VERSION 16 2019.05.27

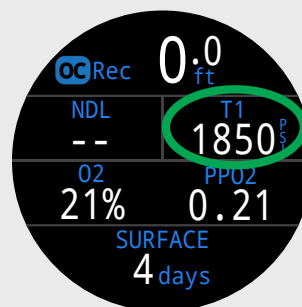
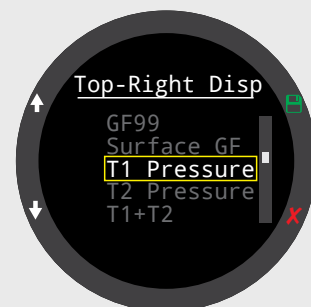
IMPROVE In the OC Rec Standard layout the TTS (top-right) location can be replaced by alternate displays.
