Shearwater Teric Firmware Release Notes

VERSION 17 **2020.03.04**

Shearwater Teric Firmware v16 Release Notes

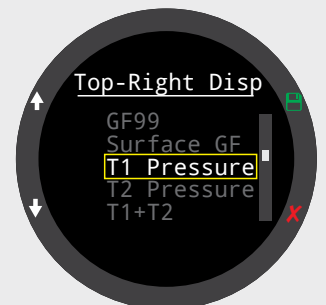
IMPROVE In the OC Rec Standard layout the TTS (top-right) location can be replaced by alternate displays.
